Certificate of Thorough Examination & NDT of Lifting Equipment

Client Name:	Hilong Oil Services & Engineering	Rig Number:	HL099	Job Number:	ATS-05-24-3200
---------------------	--	--------------------	--------------	--------------------	-----------------------

Date of Examination:	16/05/2024	Date of Report:	16/05/2024	Certificate No:	ATS-05-24-3200-109
-----------------------------	-------------------	------------------------	-------------------	------------------------	---------------------------

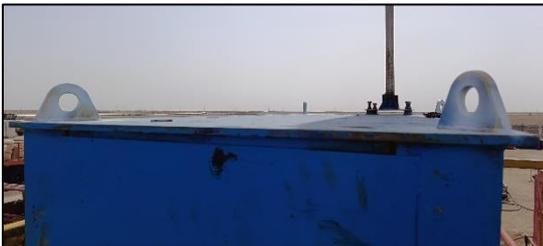
Serial Number:	QTY	Description	SWL	Date of last Thorough examination
3 4	02	Fabricated Pad Eyes Pad Eye Dimension Thickness: 10 MM Pin Hole : 31 MM Length : 104 MM Height : 68 MM Location: TOOL BOX ON MUD TANK SN: TB-02	1 TONS	N/A

NDT Results	
Visual and MPI carried out for the above description and found free of surface defects at the time of inspection	
Identification of any part found to have a defect and a description of the defect: NONE	
Particulars of any repair, renewal or alteration required to remedy the defect identified above: NONE
