| Type Of Inspection: | CAT III INSPECTION | Report No: | ATS-05-24-3200-HS-004 |
| Rig & Rig Number: | RIG-99 | Specification: | API RP 8C |

| Equipment: | Hand Slip (Drill pipe slip), SDML 3 ½ |

## Visual & Magnetic Particles Examination Report

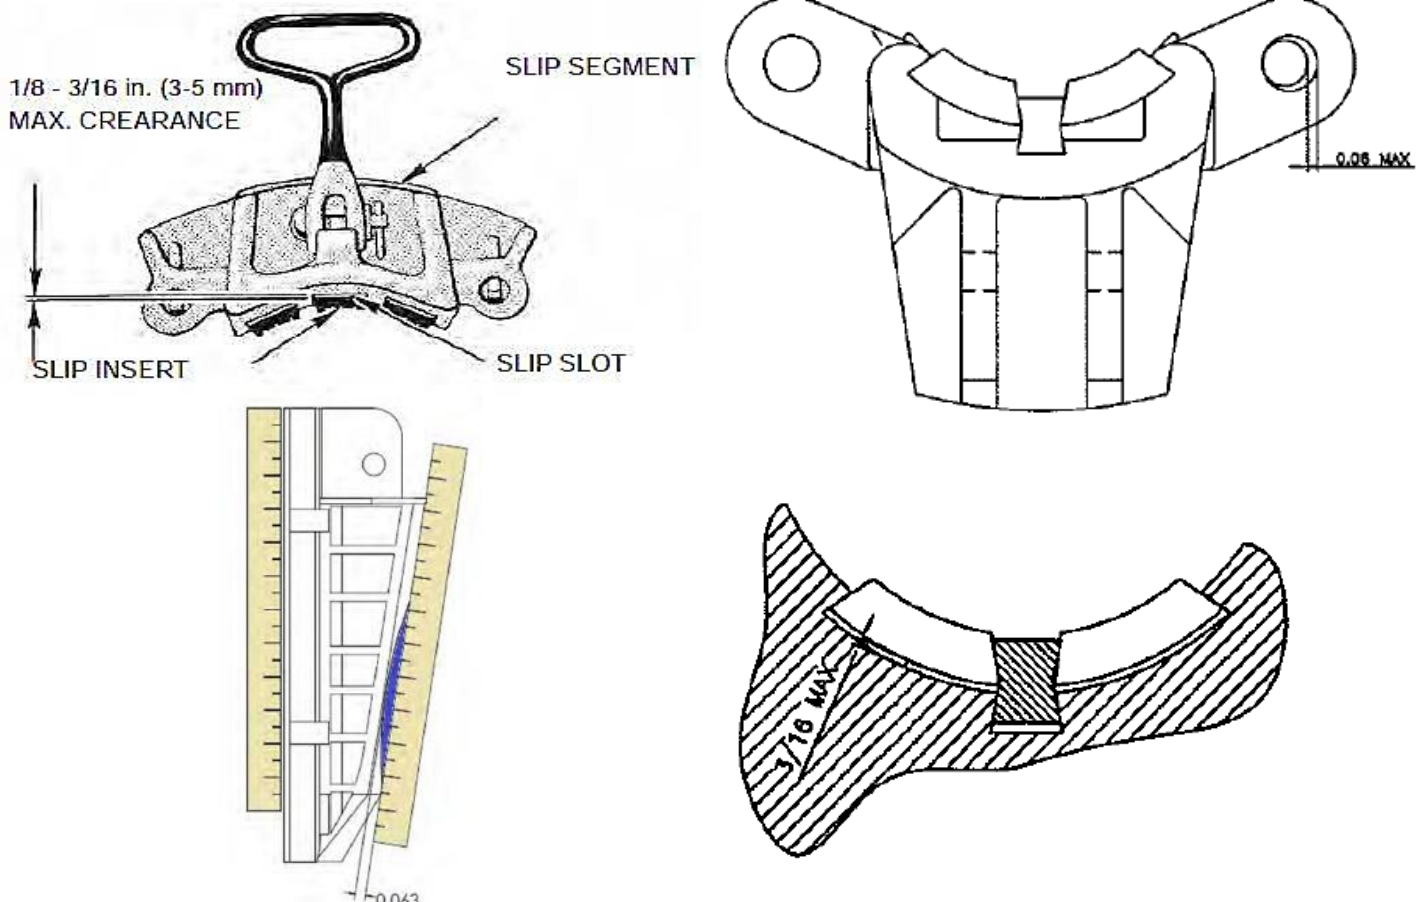
- The Drill pipe Slip Has Been Inspected and Found Conformable to the Relevant Standard(s)
- The Rig was equipped with JIANGSU RUTONG PTERO-MACHINERY CO. LTD Drill pipe Slip.
- Drill pipe Slip Found Stripped Down for CAT III Inspection.

| Action | Result |
|---|---|
| • Visually check for any damage, missing parts or cracks | Pass |
| • Place a straight edge against the backs and inside face of the slips to check if they are bend or wear. A good slip back is straight, smooth, and well-greased. | Pass |
| • Perform MPI as Per Manufacture's Recommendations of Hinged Connections Body (inside & Outside), Handles Guide Halves, Slips Top Cover Halves, Etc... | Pass |

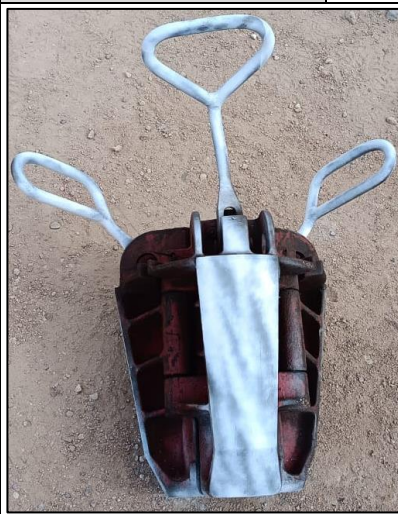
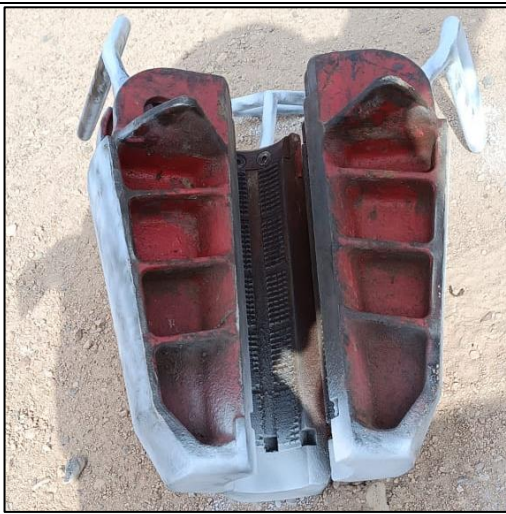
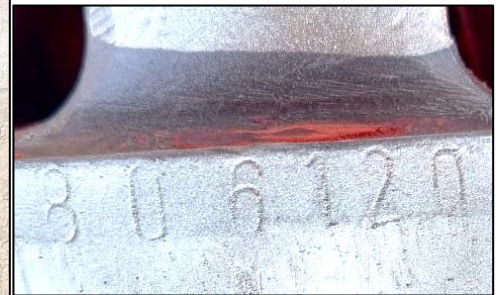
| Serial Number | Description of the examined equipment | Result |
|---|---|---|
| S/N: | 806120 | |

Visual and MPI carried out for the above description and found free of surface defects at the time of inspection

Identification of any part found to have a defect and a description of the defect: **None**

Particulars of any repair, renewal or alteration required to remedy the defect identified above: **None**
