Aberdeen Technical Services and General Transportation

Certificate of Visual Thorough Examination and Magnetic Particle Inspection (MPI)

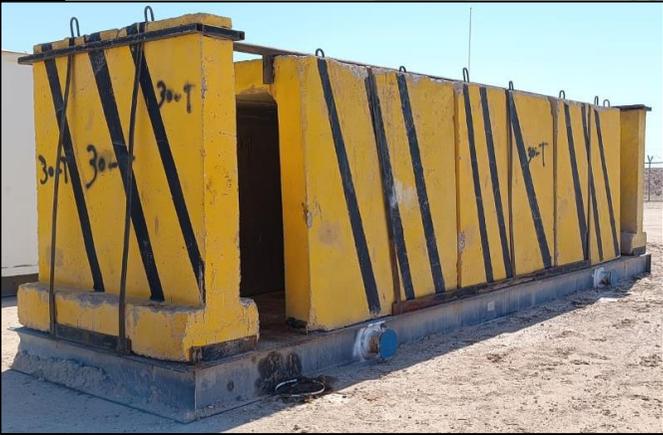
<table><tr> <td>SN</td> <td>1</td> <td>3</td> </tr><tr> <td>SN</td> <td>2</td> <td>4</td> </tr><tr> <td>SWL</td> <td colspan="2">10 TONS</td> </tr></table>

SN	1	3	SN	2	4	SWL	10 TONS	
		SN	1	3								
		SN	2	4								
		SWL	10 TONS									
Unit Serial Number: BS99-1												
Details of inspection method(s): Visible magnetic particle inspection												
Inspection Results: MPI WAS CARRIED OUT ON THE CRITICAL AND WELDING AREAS OF LIFTING POINTS OF THE ABOVE-MENTIONED ITEM AND FOUND NO CRACKS OR RELEVANT INDICATIONS AT THE TIME OF INSPECTION.												
Remarks: ACCEPTED												
Inspection Equipment Details		Personnel Details										
Equipment	Ac yoke	Inspector:	Aram Dlawar									
Serial Number	201504044	Qualifications	ASNT LEVEL II									
Calibration Date:	05-01-2024	Date:	09-05-2024									
Calibration Due:	04-07-2024	Signature:
