# Aberdeen Technical Services and General Transportation

## Certificate of Visual Thorough Examination and Magnetic Particle Inspection (MPI)

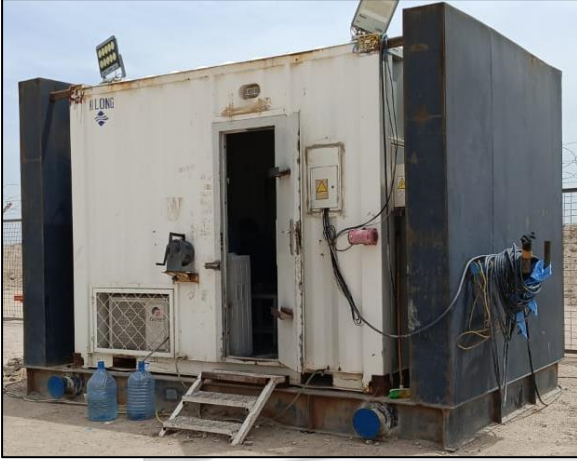
<table><tr> <td>SN</td><td>01-01</td><td>01-03</td></tr><tr> <td>SN</td><td>01-02</td><td>01-04</td></tr><tr> <td>SWL</td><td colspan="2">60 KN</td></tr></table>
