Customer:	Hilong Oil Services & Engineering	Date Of Service:	16-05-2024
Type Of Inspection:	CAT III INSPECTION	Report No:	ATS-05-24-3200-SJE-001
Rig & Rig Number:	RIG-99	Specification:	API RP 8C

The Rig Was Equipped with JIANGSU RUTONG PETRO-MACHINERY CO. Single Joint Elevator, with The Following Specification:

Equipment:	Single Joint Elevator, SJ 2 7/8
SN:	80823
Date of Manufacture:	-
Manufacturer/ Model:	JIANGSU RUTONG PETRO-MACHINERY CO.
Reference Standard:	API RP 8C
Next Examination Date:	After 6 Months

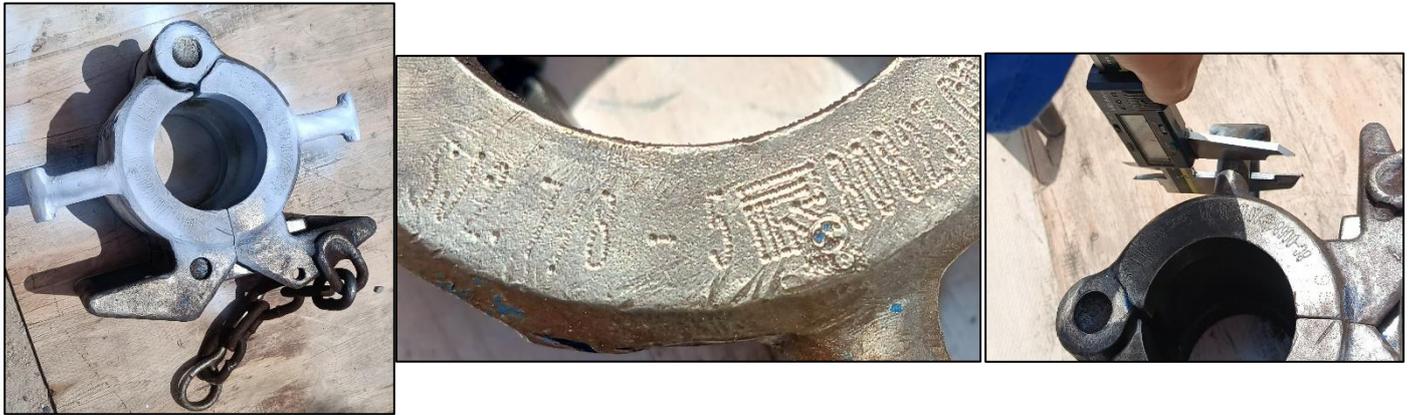
Serial Number	Description of the examined equipment	Result
80823	Single Joint Elevator, SJ 2 7/8	Pass
S/N:	80823

Visual and MPI carried out for the above description and found free of surface defects at the time of inspection

Identification of any part found to have a defect and a description of the defect: **None**

Particulars of any repair, renewal or alteration required to remedy the defect identified above: **None**
