Customer:	Hilong Oil Services & Engineering	Date Of Service:	06-June-2024
Type Of Inspection:	CAT III INSPECTION	Report No:	ATS-05-24-3200-MT-002
Rig & Rig Number:	RIG-99	Specification:	API RP 7L

Equipment:	Manual Tong 2 3/8” – 10 3/4”
Model/SN:	XK14-002-00018, SY/T 5074-2012, SN: 808061
Date of Manufacture:	2018-8
Manufacturer:	Jiangsu Rutong Petro-Machinery Co., Ltd.
Reference Standard:	API RP 7L
Next Examination Date:	After 06 months

Visual & Magnetic Particles Examination Report

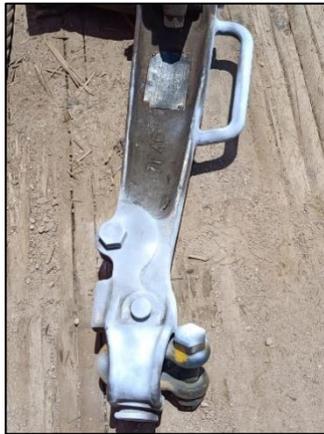
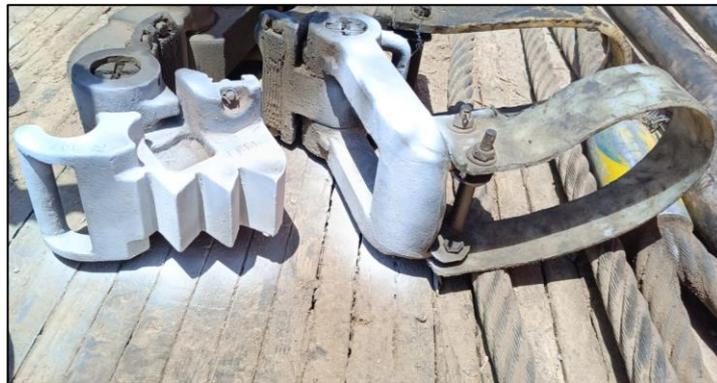
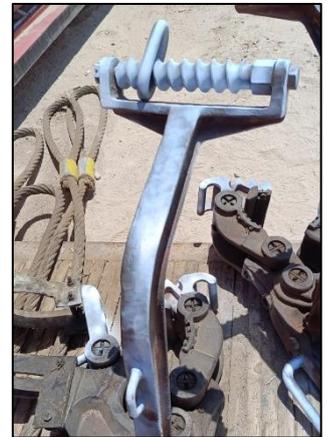
Serial Number	Description of the examined equipment	Result
808061	Manual Tong 2 3/8" – 10 3/4"	Pass
S/N:	808061

Visual and MPI carried out for the above description and found free of surface defects at the time of inspection

Identification of any part found to have a defect and a description of the defect: **None**

Particulars of any repair, renewal or alteration required to remedy the defect identified above: **None**
