Customer:	Hilong Oil Services & Engineering	Date Of Service:	09-June-2024
Type Of Inspection:	CAT III INSPECTION	Report No:	ATS-06-24-3466-CRB-001
Rig & Rig Number:	RIG-100	Specification:	API RP 8B, API RP 4G

Equipment:	Crown Block
Model:	STC180
S/N:	180701
Marker & Date of Manufacture:	SJ PETROLEUM MACHINERY / 07-2018
Ref Standard:	API RP 4G, API RP 8B
Inspection Frequency:	Every 06 Months

***Crown block Sheaves - Groove Depth Measurements**

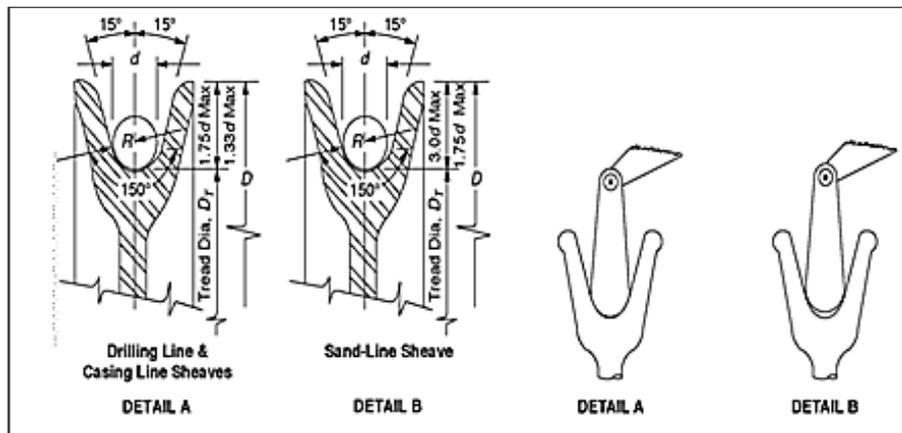
Sheaves No:	Nominal Wire Rope Dim:	Actual Depth:	Max Allowable Groove Depth =1.75 d	Min Allowable Groove Depth =1.33 d	Remarks/Results
01	29	49.40	50.75	38.57	Accepted
02	29	49.45	50.75	38.57	Accepted
03	29	49.40	50.75	38.57	Accepted
04	29	49.30	50.75	38.57	Accepted
05	29	49.40	50.75	38.57	Accepted
06	29	49.49	50.75	38.57	Accepted

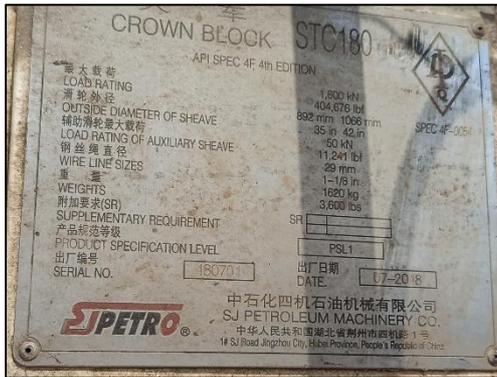
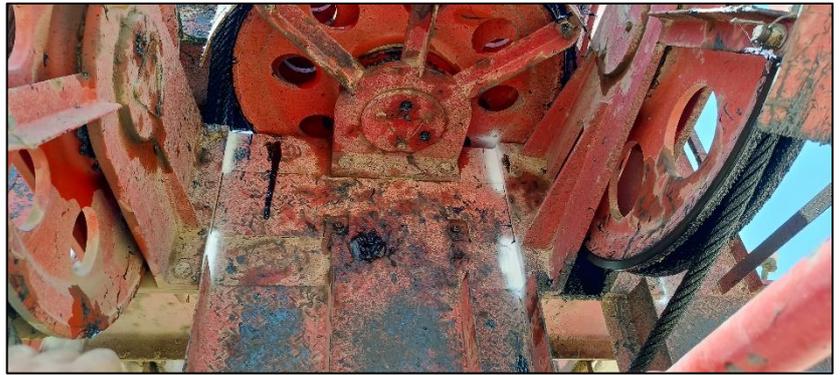
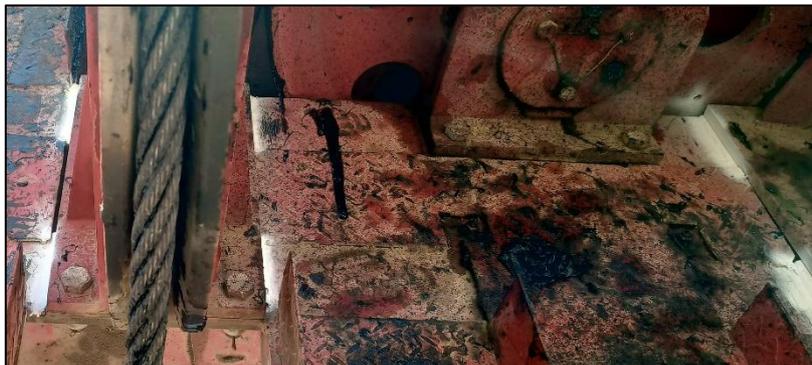
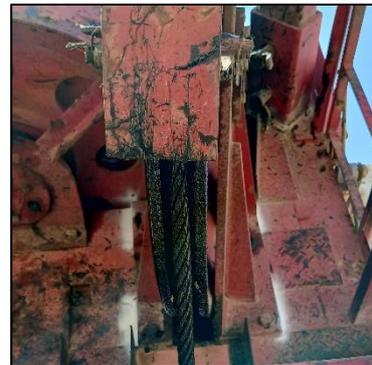
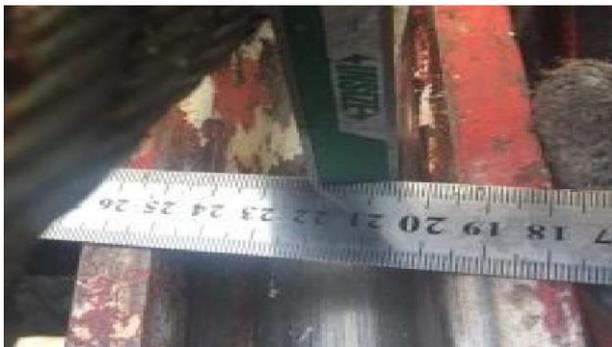
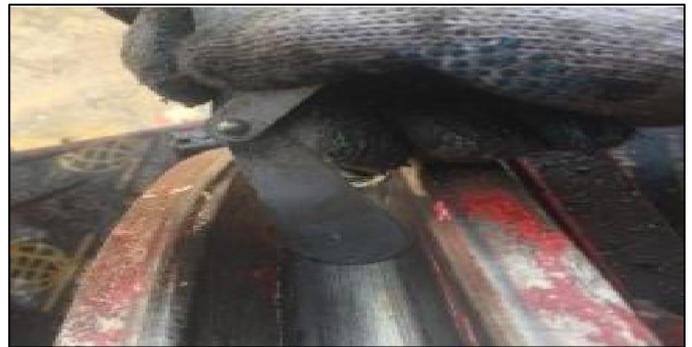
PICTORIAL

** Visual and MPI Was Carried Out on the Available Welding & Critical Areas of the Crown Block and Found **Satisfactory for Further Use.**

** CAT III Inspection Was Carried Out on Crown Block and Found **Accepted** at The Time of Inspection.
