Aberdeen Technical Services and General Transportation

Certificate of Visual Thorough Examination and Magnetic Particle Inspection (MPI)

Client:	Hilong Oil Services & Engineering	Certificate Number:	ATS-06-24-3466- MPI-011										
Rig Number:	HL100	Job No:	ATS-06-24-3466										
Location:	Northern Rumila – R-055	Page No:	01 of 01										
Date of Inspection:	12-06-2024	Next Inspection Date:	11-12-2024										
Type of Inspection	Visual inspection & MPI (Wet Visible Method)	Ref. Standards:	ASTM E709, ASTM E 1444										
PICTORIAL:

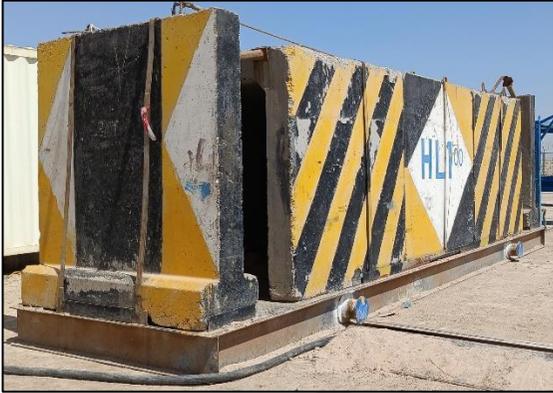
Item Description: bunker camp <table border="1"> <tr> <td>SN</td> <td>01</td> <td>02</td> <td>03</td> <td>04</td> </tr> <tr> <td>SWL</td> <td colspan="4">10 T</td> </tr> </table>		SN	01	02	03	04	SWL	10 T			
		SN	01	02	03	04							
SWL	10 T												
Unit Serial Number: BB-02		Details of inspection method(s): Visible magnetic particle inspection											
Inspection Results: MPI WAS CARRIED OUT ON THE WELDING AND CRITICAL AREAS OF THE LIFTING POINTS OF THE ABOVE-MENTIONED ITEM AND FOUND NO CRACKS OR RELEVANT INDICATIONS AT THE TIME OF INSPECTION.		Remarks: ACCEPTED											
Inspection Equipment Details		Personnel Details											
Equipment	Ac yoke	Inspector:	Aram Dlawar										
Serial Number	201504044	Qualifications	ASNT LEVEL II										
Calibration Date:	05-01-2024	Date:	12-06-2024										
Calibration Due:	04-07-2024	Signature:
