# Aberdeen Technical Services and General Transportation

## Certificate of Visual Thorough Examination and Magnetic Particle Inspection (MPI)

Client:	<b>Hilong Oil Services &amp; Engineering</b>	Certificate Number:	ATS-06-24-3466- MPI-013
Rig Number:	HL100	Job No:	ATS-06-24-3466
Location:	Northern Rumila – R-055	Page No:	01 of 01
Date of Inspection:	12-06-2024	Next Inspection Date:	11-12-2024
Type of Inspection	Visual inspection & MPI (Wet Visible Method)	Ref. Standards:	ASTM E709, ASTM E 1444

**Item Description: Fire fighter**

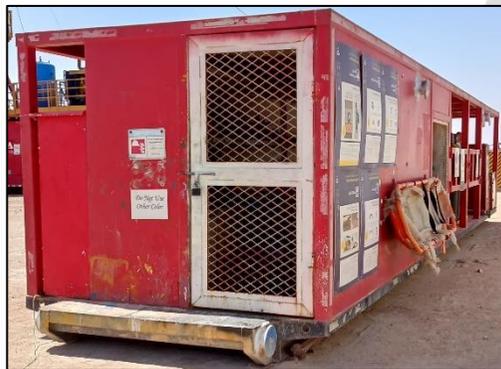
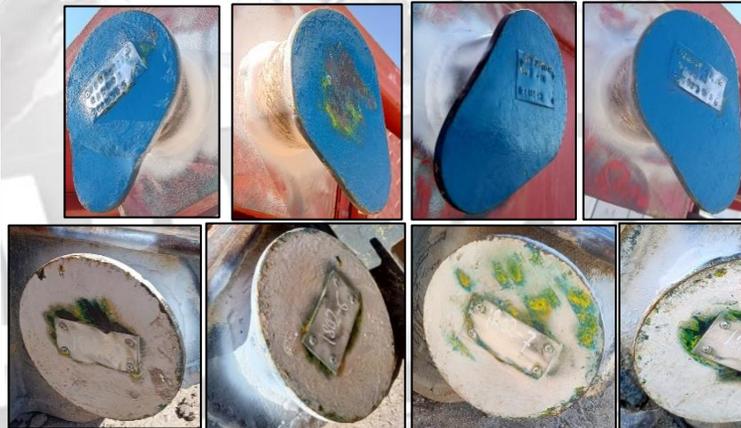
**PICTORIAL:**

**Unit Serial Number:**  
XFG-180

**Inspection Results:**  
MPI WAS CARRIED OUT ON THE WELDING AND CRITICAL AREAS OF THE LIFTING POINTS OF THE ABOVE-MENTIONED ITEM AND FOUND NO CRACKS OR RELEVANT INDICATIONS AT THE TIME OF INSPECTION.

**Remarks: ACCEPTED**
