Certificate of Visual Thorough Examination and Magnetic Particle Inspection (MPI)

Client:	Hilong Oil Services & Engineering	Certificate Number:	ATS-06-24-3466- MPI-025
Rig Number:	HL100	Job No:	ATS-06-24-3466
Location:	Northern Rumila – R-055	Page No:	01 of 01
Date of Inspection:	12-06-2024	Next Inspection Date:	11-12-2024
Type of Inspection	Visual inspection & MPI (Wet Visible Method)	Ref. Standards:	ASTM E709, ASTM E 1444

Item Description: mud tank

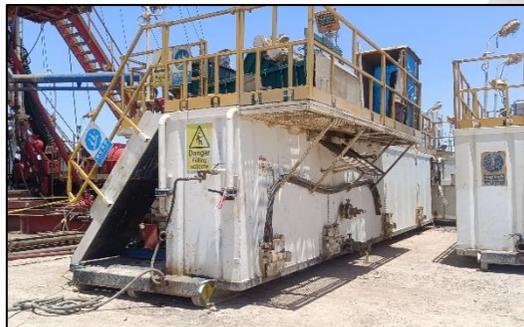
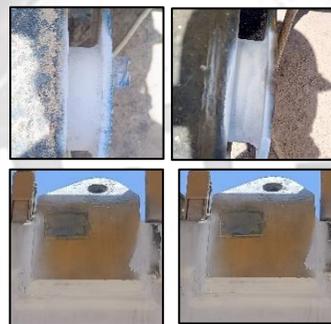
PICTORIAL:

Mud tank	
TYPE	NJG-1
CAPACITY	49 m ³
MASS	16900 kg
DIMENSTON	12600×3200×3000mm
STANDARD	Q/HED 006-2017
SERIAL No.	18065
OUTPUT DATE	2018.11

SN	18065-1	18065-4	18065-6	18065-7
SWL	50 KN

MPI WAS CARRIED OUT ON THE WELDING AND CRITICAL AREAS OF THE LIFTING POINTS (02 LIFTING LUGS + 02 LIFING PADEYES) OF THE ABOVE-MENTIONED ITEM AND FOUND NO CRACKS OR RELEVANT INDICATIONS AT THE TIME OF INSPECTION.

Remarks: ACCEPTED
