## Certificate of Visual Thorough Examination and Magnetic Particle Inspection (MPI)

**Item Description: mud system ladder**

**Unit Serial Number:**  
**LMS-1**

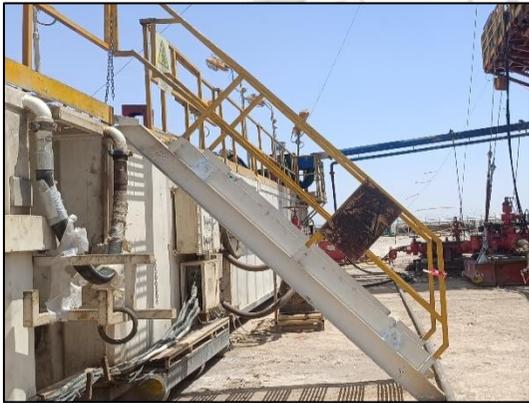
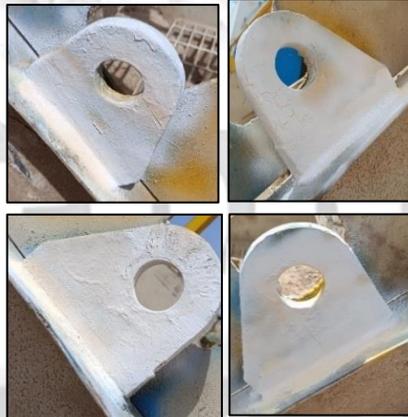
**PICTORIAL:**

**Inspection Results:**  
MPI WAS CARRIED OUT ON THE WELDING AND CRITICAL AREAS OF THE LIFTING POINTS OF THE ABOVE-MENTIONED ITEM AND FOUND NO CRACKS OR RELEVANT INDICATIONS AT THE TIME OF INSPECTION.

**Remarks: ACCEPTED**
