Customer:	Hilong Oil Services & Engineering	Date Of Service:	16-July-2024
Type Of Inspection:	CAT III INSPECTION	Report No:	ATS-07-24-4007-009
Rig & Rig Number:	RIG HL99	Specification:	API RP 8B

The Rig Was Equipped with Hubei Jiangnan Petroleum Instrument & Meter CO. Deadline Anchor, with The Following Specification:

Equipment:	Deadline Anchor
SN:	Q0502
MODEL:	JZG 20A
Date of Manufacture:	2018.08.02
Ref. Standard(s):	API 8B
Manufacturer:	Hubei Jiangnan Petroleum Instrument & Meter CO

Visual & Magnetic Particles Examination Report

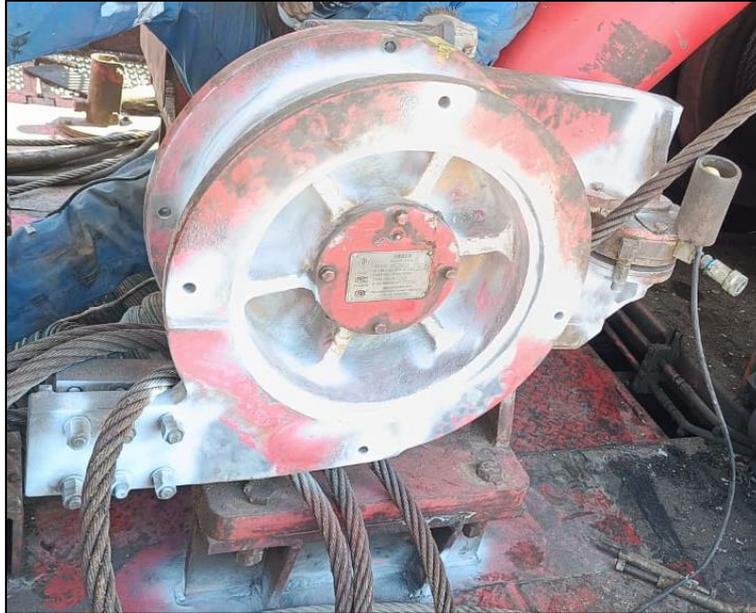
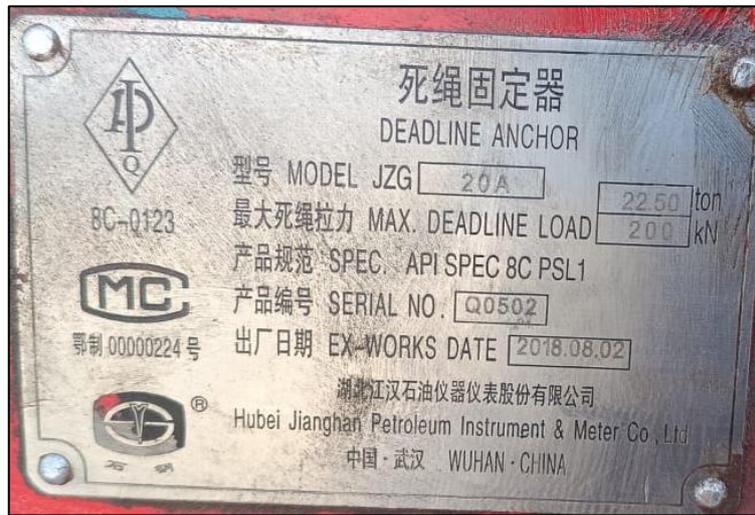
PICTORIAL:

** Visual And MPI Was Carried out on The Available Welding and Critical Areas Of The Deadline Anchor and Found **Satisfactory for Further Use**.

** CAT III Inspection Was Carried Out on A Deadline Anchor and Found **Accepted** At The Time of Inspection.

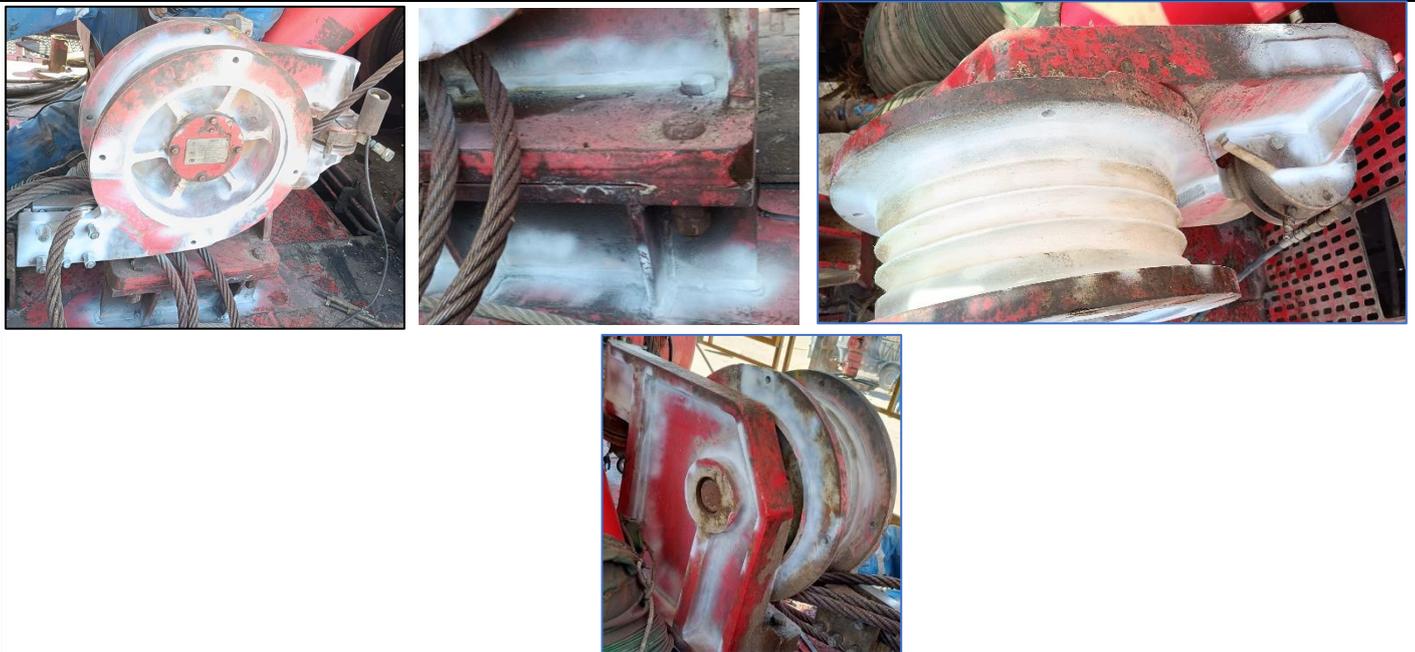
Visual and MPI carried out for the above-mentioned items and found free of surface defects at the time of inspection

Identification of any part found to have a defect and a description of the defect: **None**

Particulars of any repair, renewal or alteration required to remedy the defect identified above: **None**
