Customer:	Hilong Oil Services & Engineering	Date Of Service:	08-08-2024
Type Of Inspection:	CAT IV INSPECTION	Report No:	ATS-08-24-4132-EL-030
Rig & Rig Number:	RIG-100	Specification:	API RP 8B

The Rig Was Equipped with SJ PETROUM MACHINERY CO. Square Shoulder Elevator, with The Following Specification:

Equipment:	Square Shoulder Elevator, DD 4 ½ EU -150 TB
Model/SN:	80837
Date of Manufacture:	-
Manufacturer:	JIANGSU RUTONG PETRO-MACHINERY CO.
Reference Standard:	API RP 8B
Next Examination Date:	After 1 Year

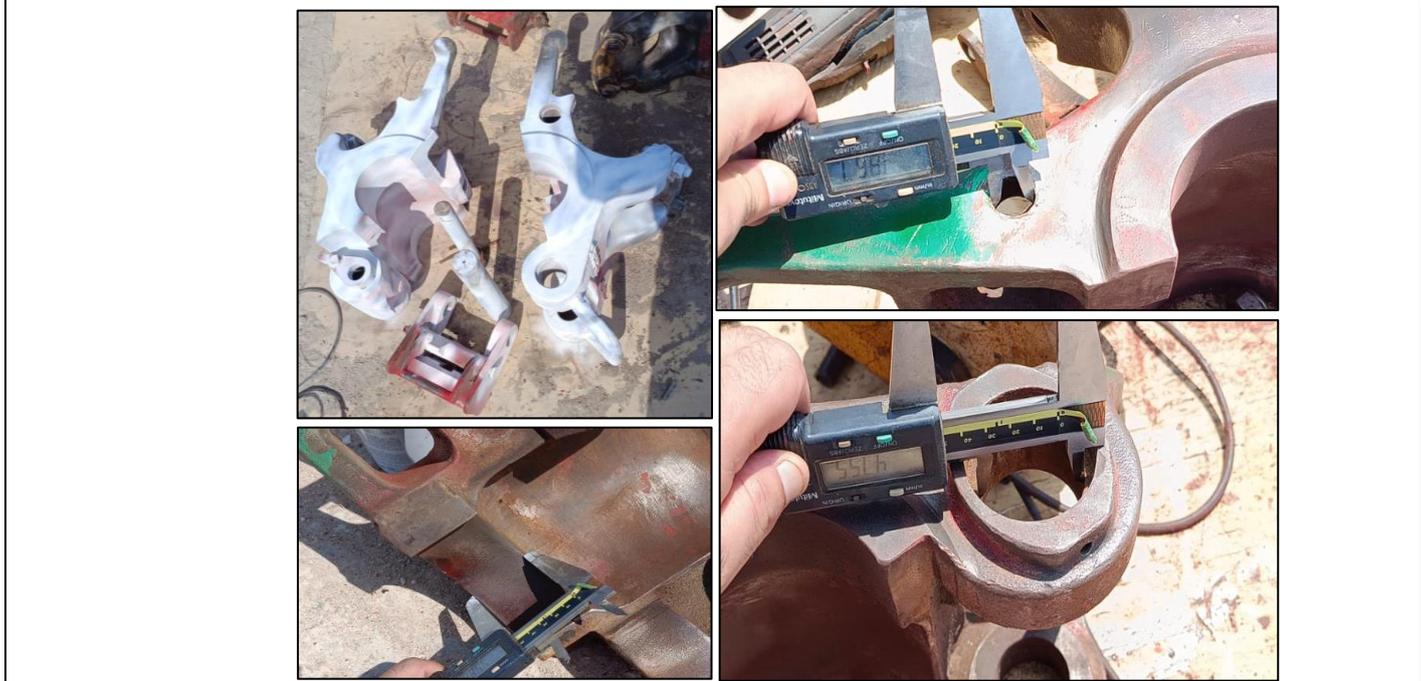
Serial Number	Description of the examined equipment	Result
80837	Square Shoulder elevator, DD 4 ½ EU – 150 TB	Pass
S/N:	-

Visual and MPI carried out for the above description and found free of surface defects at the time of inspection

Identification of any part found to have a defect and a description of the defect: **None**

Particulars of any repair, renewal or alteration required to remedy the defect identified above: **None**

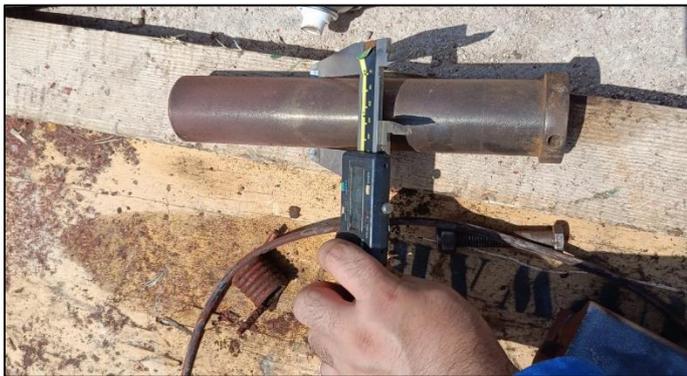
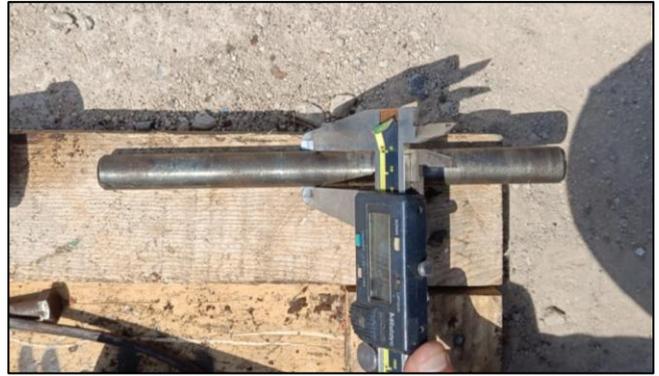
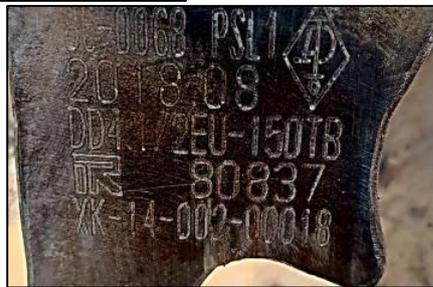
Serial Number	Description of the examined equipment	Result
80837	Square Shoulder elevator 4 ½ EU – 150 TB	Pass
S/N:	-

Visual and MPI carried out for the above description and found free of surface defects at the time of inspection

Identification of any part found to have a defect and a description of the defect: **None**

Particulars of any repair, renewal or alteration required to remedy the defect identified above: **None**
