| Type Of Inspection: | CAT IV INSPECTION | Report No: | ATS-08-24-4132-EL-031 |
| Rig & Rig Number: | RIG-100 | Specification: | API RP 8B |

| Equipment: | Drill Pipe Elevator, DDZ 2 7/8 EU - 150 |

## Visual & Magnetic Particles Examination Report

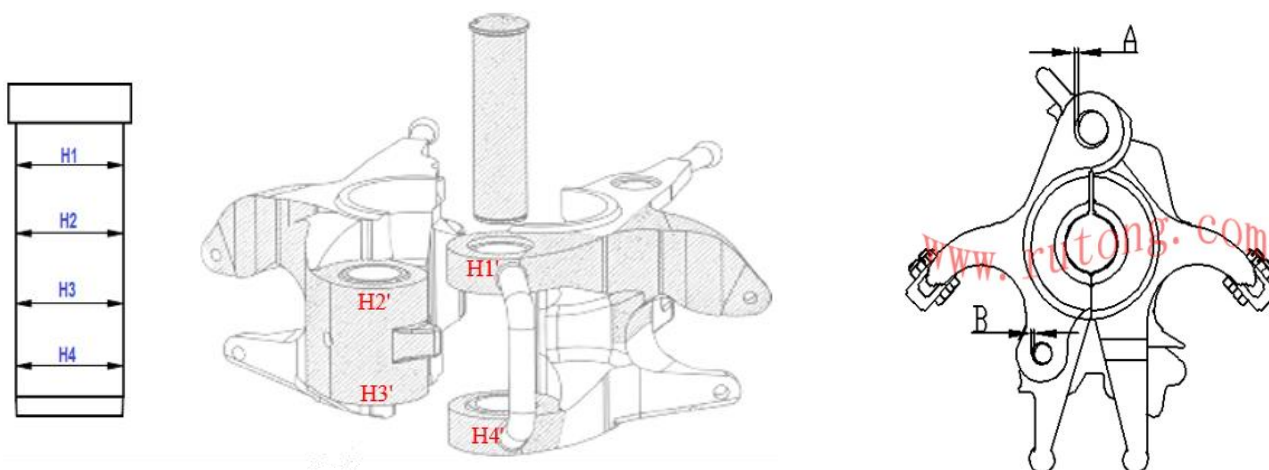
| DESCRIPTION | VALUES | OEM VALUES | RESULT |
|---|---|---|---|
| The maximum allowable wear tolerance of (D) | 98 mm | 92 mm | Accepted |
| The distance "E" from the center line to the center of Arc | 162 mm | 162 mm | Accepted |
| Drill Pipe Elevator Cone Angle | 18° | Max. 16° | Accepted |
| The minimum allowable thickness of the elevator load bearing point contact surface (G) | 58 mm | Min. 55 mm | Accepted |
| The design Value for radius "R" at the force point | 50 mm | 50 mm | Accepted |

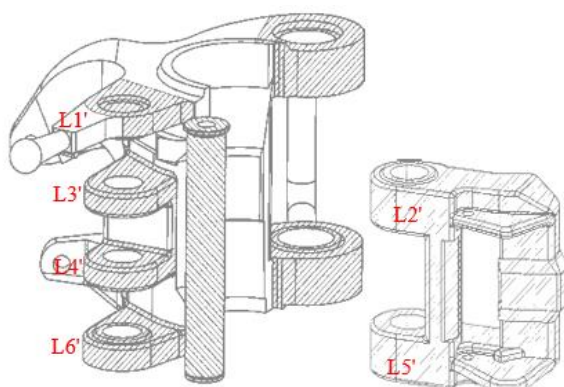
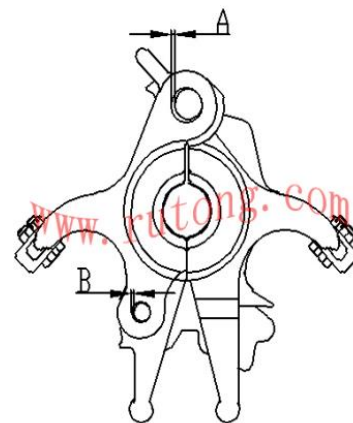
2.

| Measurement | Nominal | Tolerance (B) | Actual Reading | Result |
|---|---|---|---|---|
| Latch Pin OD (L1) | 32.32 | 0.76 | 32.30 | Accepted |
| Latch Pin OD (L2) | 32.32 | | 32.30 | Accepted |
| Latch Pin OD (L3) | 32.32 | | 32.31 | Accepted |
| Latch Pin OD (L4) | 32.32 | | 32.29 | Accepted |
| Latch Hole ID (L1') | 32.40 | | 32.54 | Accepted |
| Latch Hole ID (L2') | 32.40 | | 32.55 | Accepted |
| Latch Hole ID (L3') | 32.40 | | 32.53 | Accepted |
| Latch Hole ID (L4') | 32.40 | | 32.50 | Accepted |

\*\* Visual And MPI Was Carried out on the critical areas and load bearing components of the elevator and Found **Satisfactory for Further Use**.

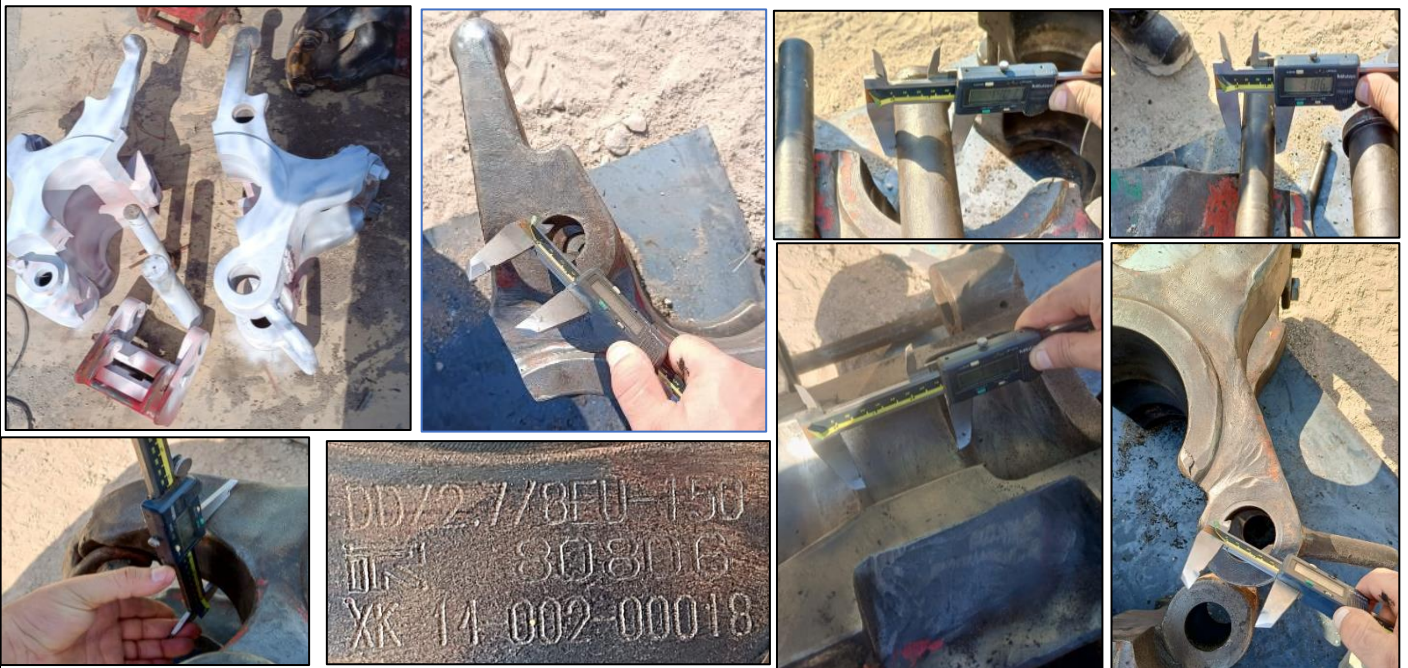
| Serial Number | Description of the examined equipment | Result |
|---|---|---|
| 80806 | Drill Pipe Elevator, DDZ 2 7/8 EU - 150 | Pass |

Visual and MPI carried out for the above description and found free of surface defects at the time of inspection

Identification of any part found to have a defect and a description of the defect: **None**

Particulars of any repair, renewal or alteration required to remedy the defect identified above: **None**
