# ABERDEEN TECHNICAL SERVICES AND GENERAL TRANSPORTATION

## SINGLE JOINT ELEVATOR - CAT IV INSPECTION REPORT

| Type Of Inspection: | CAT IV INSPECTION | Report No: | ATS-08-24-4132-SJE-001 |

| Equipment: | Single Joint Elevator, SJ 3 ½ EU-5 |

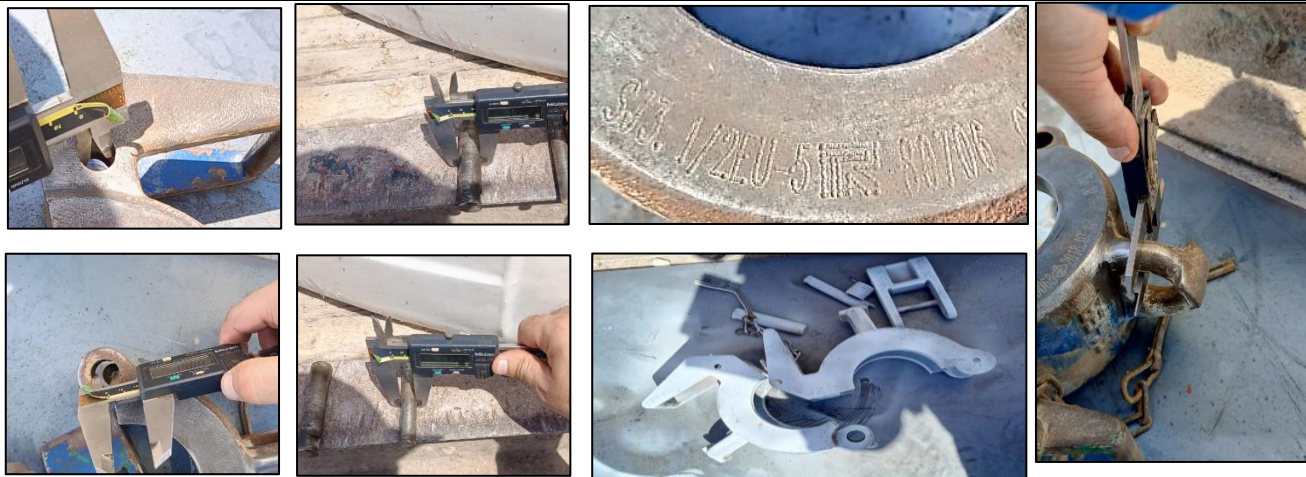
| Serial Number | Description of the examined equipment | Result |
|---|---|---|
| 80706 | Single Joint Elevator, SJ 3 1/2 EU-5 | Pass |

Visual and MPI carried out for the above description and found free of surface defects at the time of inspection

Identification of any part found to have a defect and a description of the defect: **None**
