# ABERDEEN TECHNICAL SERVICES AND GENERAL TRANSPORTATION

## SINGLE JOINT ELEVATOR - CAT IV INSPECTION REPORT

| Type Of Inspection: | CAT IV INSPECTION | Report No: | ATS-08-24-4132-SJE-005 |

| Equipment: | Single Joint Elevator, SJ 2 7/8 EU -5 |

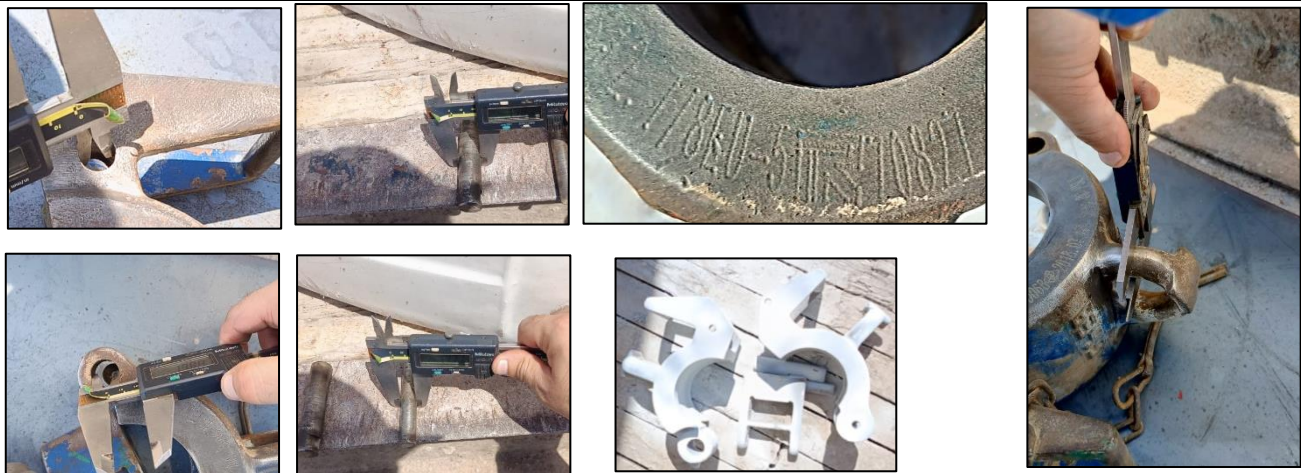
| Serial Number | Description of the examined equipment | Result |
| 70827 | Single Joint Elevator, SJ 2 7/8 EU - 5 | Pass |

Visual and MPI carried out for the above description and found free of surface defects at the time of inspection

Identification of any part found to have a defect and a description of the defect: **None**

Particulars of any repair, renewal or alteration required to remedy the defect identified above: **None**
