# ABERDEEN TECHNICAL SERVICES AND GENERAL TRANSPORTATION

## SINGLE JOINT ELEVATOR - CAT IV INSPECTION REPORT

| Type Of Inspection: | CAT IV INSPECTION | Report No: | ATS-08-24-4132-SJE-006 |

| Equipment: | Single Joint Elevator, SJ 4 1/2 EU -5 |

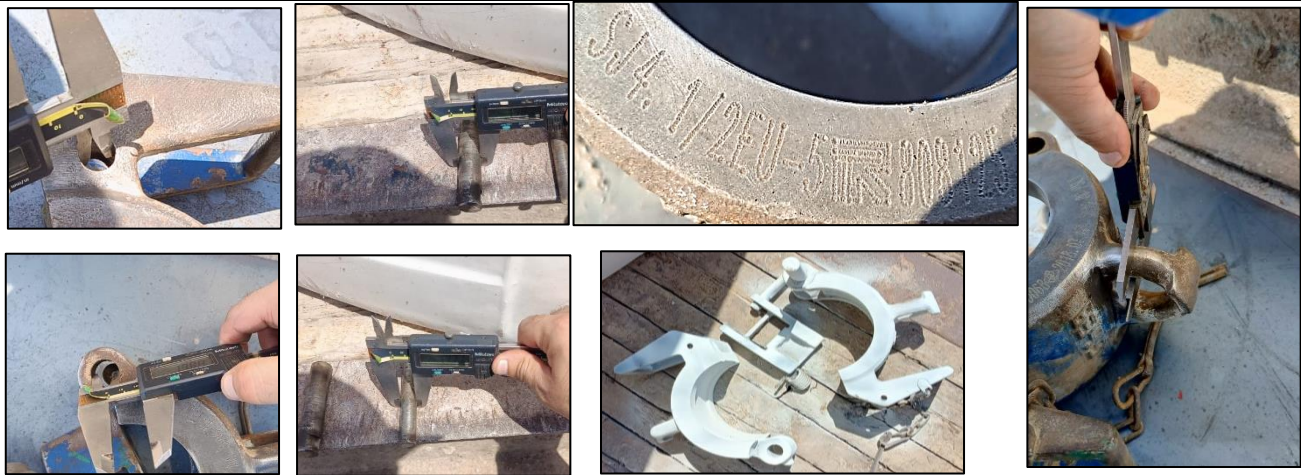
| Serial Number | Description of the examined equipment | Result |
|---|---|---|
| 808125 | Single Joint Elevator, SJ 4 ½ EU - 5 | Pass |

Visual and MPI carried out for the above description and found free of surface defects at the time of inspection

Identification of any part found to have a defect and a description of the defect: **None**

Particulars of any repair, renewal or alteration required to remedy the defect identified above: **None**
