Customer:	Hilong Oil Services & Engineering	Date Of Service:	05-08-2024
Type Of Inspection:	CAT IV INSPECTION	Report No:	ATS-08-24-4132-SJE-008
Rig & Rig Number:	RIG-100	Specification:	API RP 8B

The Rig Was Equipped with JIANGSU RUTONG PETRO-MACHINERY CO. Single Joint Elevator, with The Following Specification:

Equipment:	Single Joint Elevator, SJ 4 1/2 -5
SN:	414373009-14
Date of Manufacture:	-
Manufacturer/ Model:	JIANGSU RUTONG PETRO-MACHINERY CO.
Reference Standard:	API RP 8B
Next Examination Date:	After 1 Year

## Visual & Magnetic Particles Examination Report

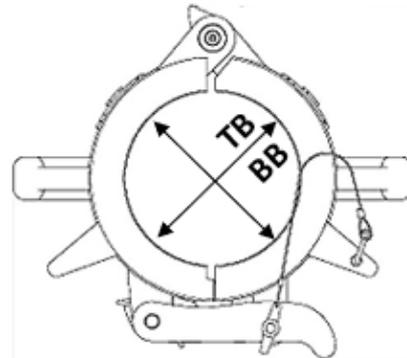
OREINTATION	DESCRIPTION	VALUES	OEM VALUES	RESULT
RIGHT	The maximum allowable wear tolerance of (D)	20mm	18.5 mm	Accepted
LEFT	The maximum allowable wear tolerance of (D)	20 mm	18.5 mm	Accepted
TOP	Maximum Allowable (Worn) Load Shoulder Bore TB	116.9 mm	118.33 mm Max	Accepted
BOTTOM	Maximum Allowable (Worn) Load Shoulder Bore BB	116.5 mm	118.33 mm Max	Accepted

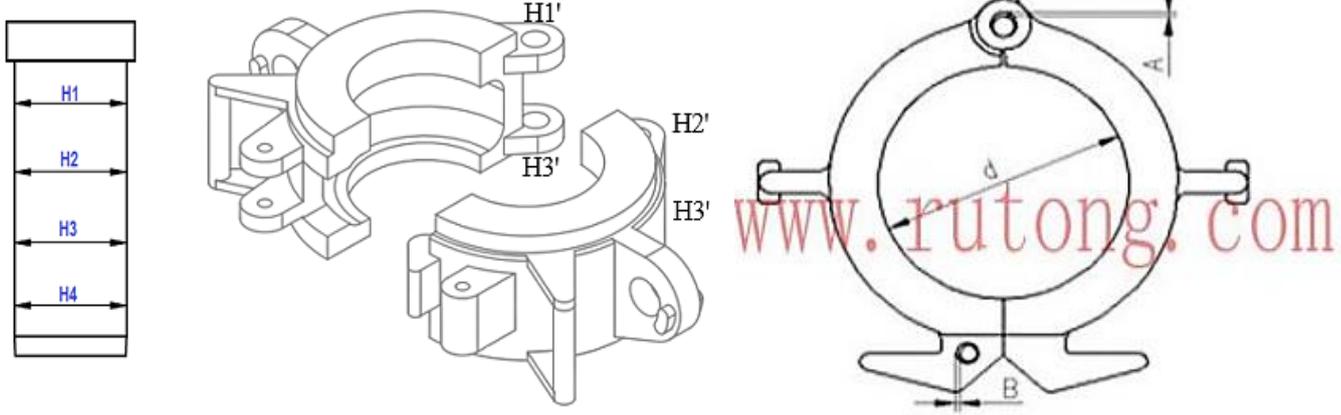
Measurement	Nominal	Tolerance (A)	Actual Reading	Result
Hinge Pin OD (H1)	19.92	0.64	19.90	Accepted
Hinge Pin OD (H2)	19.92		19.91	Accepted
Hinge Pin OD (H3)	19.92		19.91	Accepted
Hinge Pin OD (H4)	19.92		19.91	Accepted
Hinge Hole ID (H1')	20		20.07	Accepted
Hinge Hole ID (H2')	20		20.05	Accepted
Hinge Hole ID (H3')	20		20.06	Accepted
Hinge Hole ID (H4')	20		20.05	Accepted

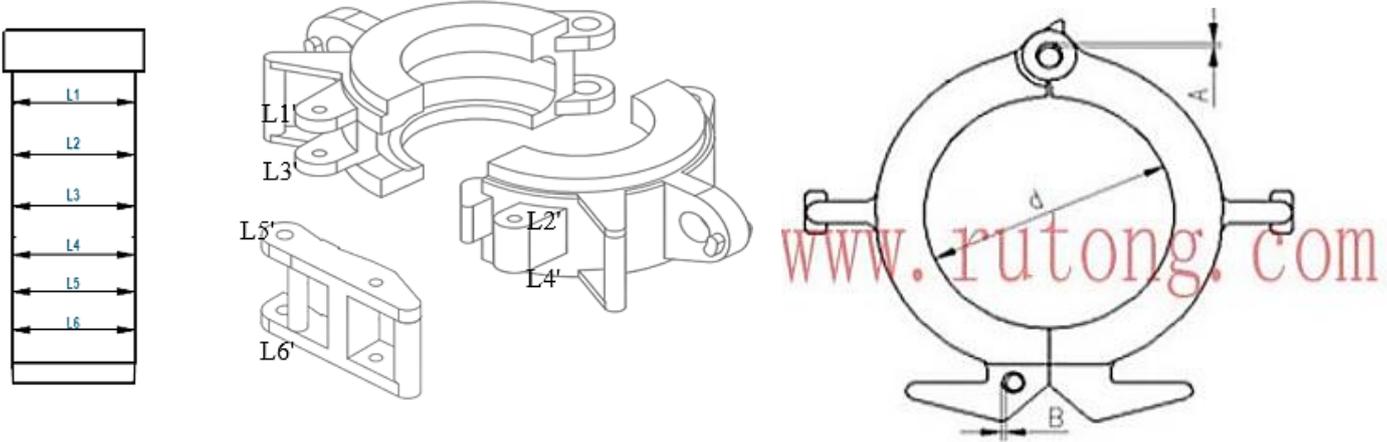
Measurement	Nominal	Tolerance (B)	Actual Reading	Result
Latch Pin OD (L1)	14.86	0.64	14.77	Accepted
Latch Pin OD (L2)	14.86		14.74	Accepted
Latch Pin OD (L3)	14.86		14.75	Accepted
Latch Pin OD (L4)	14.86		14.74	Accepted
Latch Pin OD (L5)	14.86		14.75	Accepted
Latch Pin OD (L6)	14.86		14.75	Accepted
Latch Hole ID (L1')	15.00		15.05	Accepted
Latch Hole ID (L2')	15.00		15.03	Accepted
Latch Hole ID (L3')	15.00		15.04	Accepted
Latch Hole ID (L4')	15.00		15.06	Accepted
Latch Hole ID (L5')	15.00		15.05	Accepted
Latch Hole ID (L6')	15.00		15.05	Accepted

\*\* Visual And MPI Was Carried out on the critical areas and load bearing components of the elevator and Found **Satisfactory for Further Use**.

\*\* CAT IV Inspection Was Carried Out on the Elevator and Found **Accepted** At The Time of Inspection

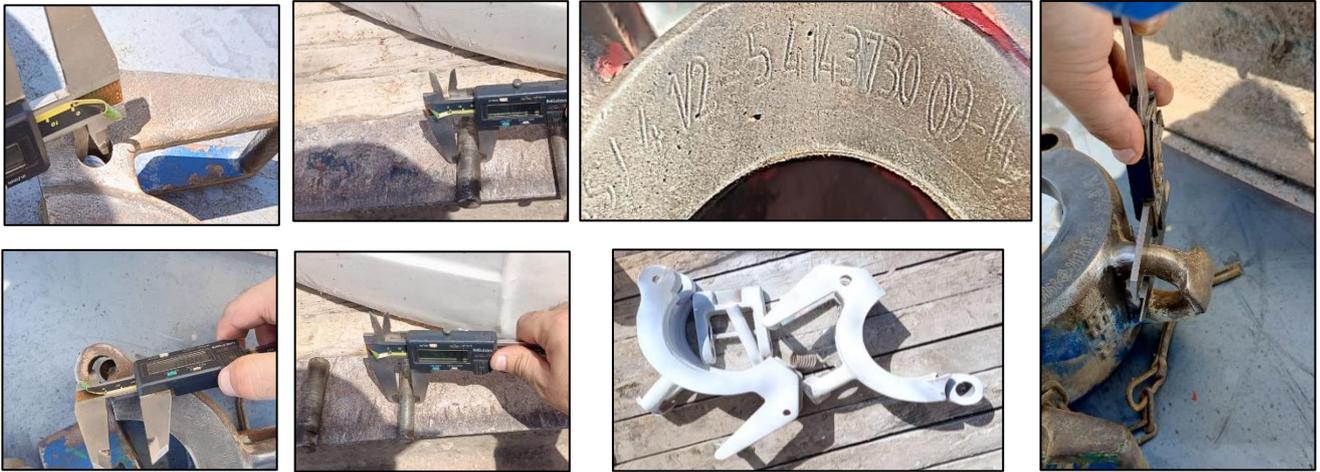
Visual and MPI carried out for the above description and found free of surface defects at the time of inspection

Identification of any part found to have a defect and a description of the defect: **None**

Particulars of any repair, renewal or alteration required to remedy the defect identified above: **None**
