# ABERDEEN TECHNICAL SERVICES AND GENERAL TRANSPORTATION

## SINGLE JOINT ELEVATOR - CAT IV INSPECTION REPORT

| Type Of Inspection: | CAT IV INSPECTION | Report No: | ATS-08-24-4132-SJE-009 |

| Equipment: | Single Joint Elevator, SJ 4-5 |

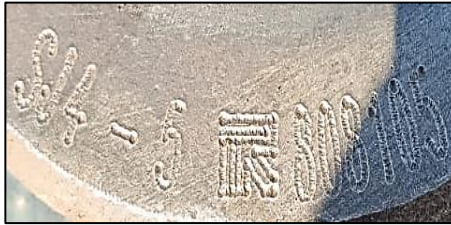
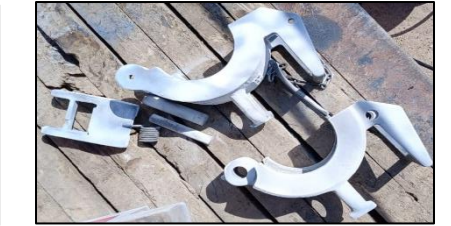
Visual and MPI carried out for the above description and found free of surface defects at the time of inspection

Identification of any part found to have a defect and a description of the defect: **None**

Particulars of any repair, renewal or alteration required to remedy the defect identified above: **None**
