## SINGLE JOINT ELEVATOR - CAT IV INSPECTION REPORT

| Type Of Inspection: | CAT IV INSPECTION | Report No: | ATS-08-24-4132-SJE-025 |

| Equipment: | Single Joint Elevator, SJ 4- 5tons |
| SN: | 808106 |

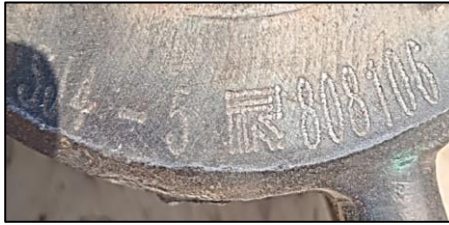
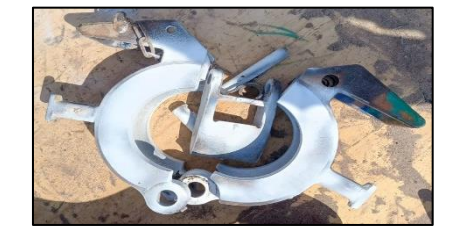
| Serial Number | Description of the examined equipment | Result |
| 808106 | Single Joint Elevator, SJ 4- 5tons | Pass |

Visual and MPI carried out for the above description and found free of surface defects at the time of inspection

Identification of any part found to have a defect and a description of the defect: **None**

Particulars of any repair, renewal or alteration required to remedy the defect identified above: **None**
