# ABERDEEN TECHNICAL SERVICES AND GENERAL TRANSPORTATION

## SINGLE JOINT ELEVATOR - CAT IV INSPECTION REPORT

| Type Of Inspection: | CAT IV INSPECTION | Report No: | ATS-08-24-4132-SJE-026 |

| Equipment: | Single Joint Elevator, SJ 4 EU- 5 ton |

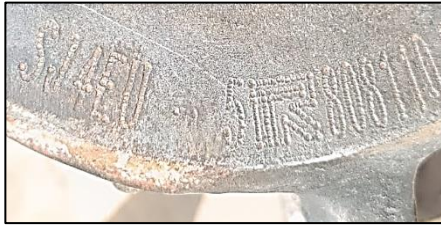
| Serial Number | Description of the examined equipment | Result |
|---|---|---|
| 808110 | Single Joint Elevator, SJ 4 EU- 5 ton | Pass |

Visual and MPI carried out for the above description and found free of surface defects at the time of inspection

Identification of any part found to have a defect and a description of the defect: **None**
