# ABERDEEN TECHNICAL SERVICES AND GENERAL TRANSPORTATION

## SINGLE JOINT ELEVATOR - CAT IV INSPECTION REPORT

| Type Of Inspection: | CAT IV INSPECTION | Report No: | ATS-08-24-4132-SJE-028 |

| Equipment: | Single Joint Elevator, SJ 4 3/4 -5 ZIP |

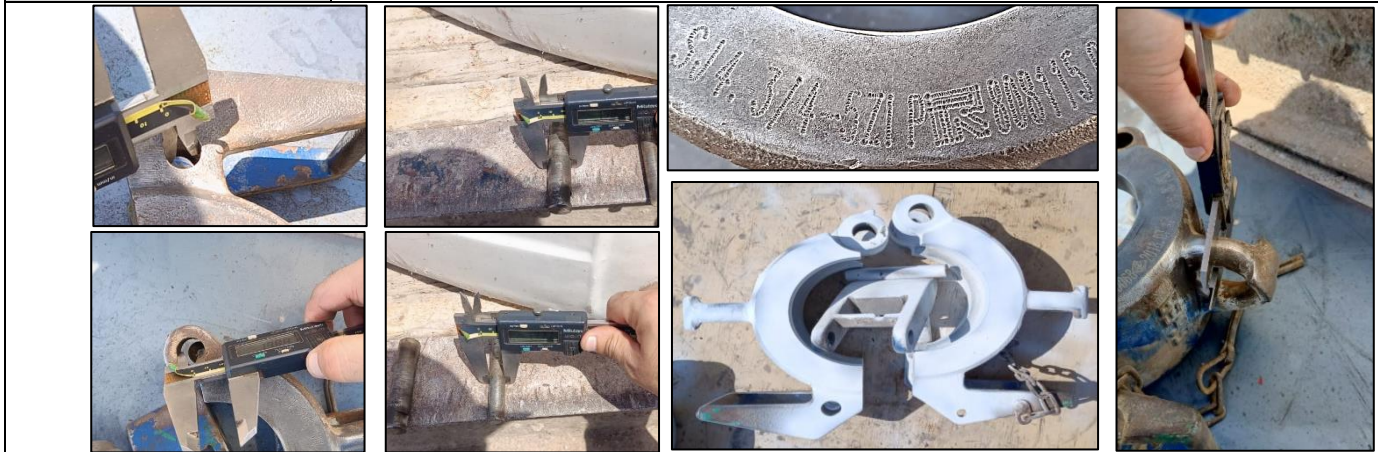
Visual and MPI carried out for the above description and found free of surface defects at the time of inspection

Identification of any part found to have a defect and a description of the defect: **None**
