# ABERDEEN TECHNICAL SERVICES AND GENERAL TRANSPORTATION

## SLIP TYPE ELEVATOR - CAT IV INSPECTION REPORT

| Type Of Inspection: | CAT IV INSPECTION | Report No: | ATS-08-24-4132-STE-020 |

| Equipment: | Slip Type Elevator, YT-75 |

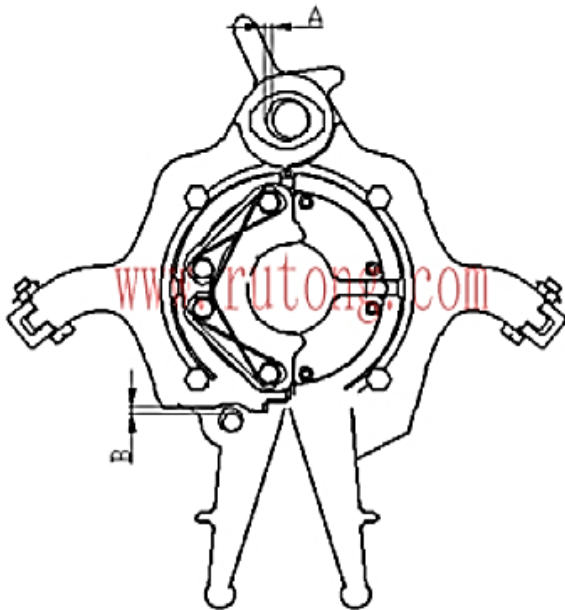
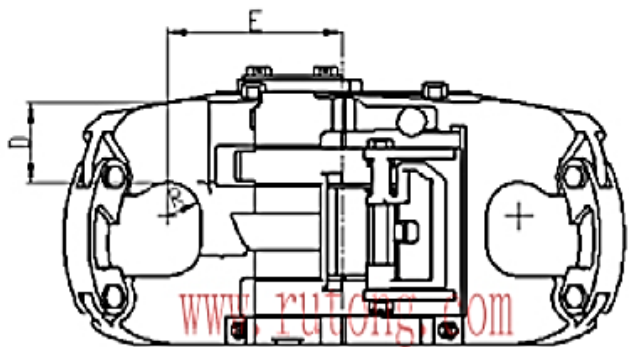
| OREINTATION | DESCRIPTION | VALUES | OEM VALUES | RESULT |
|---|---|---|---|---|
| RIGHT | The maximum allowable wear tolerance of (D) | 88 mm | 84 mm | Accepted |
| | The distance "E" from the center line to the center of Arc | 185 mm | 185 mm | Accepted |
| | The designed value for radius "R" at the force point | 40 mm | 40 mm | Accepted |
| LEFT | The maximum allowable wear tolerance of (D) | 88 mm | 84 mm | Accepted |

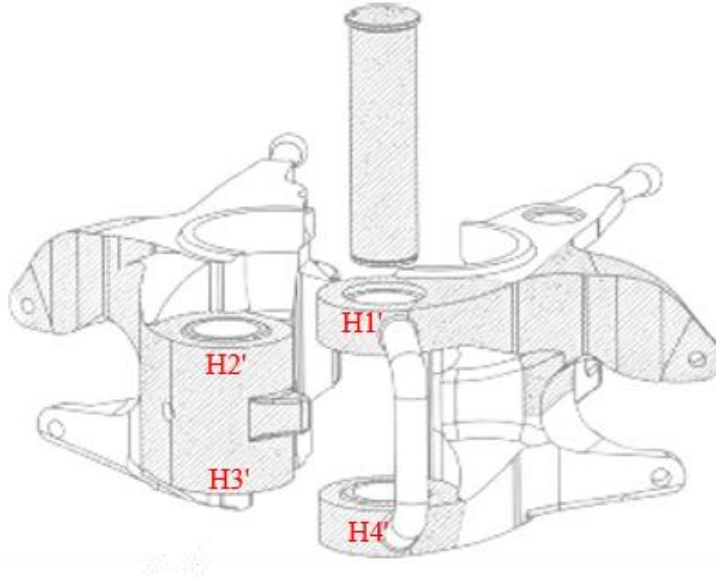
| slip type elevator – CAT IV Dimensional Verification Checklist | | | | |

| slip type elevator – CAT IV Dimensional Verification Checklist | | | | |
|---|---|---|---|---|
| Hinge Pin OD (H1) | 41.25 | 0.76 | 41.13 | Accepted |
| Hinge Pin OD (H2) | 41.25 | | 41.21 | Accepted |
| Hinge Pin OD (H3) | 41.25 | | 41.19 | Accepted |
| Hinge Pin OD (H4) | 41.25 | | 41.17 | Accepted |
| Hinge Hole ID (H1') | 41.28 | | 41.53 | Accepted |
| Hinge Hole ID (H2') | 41.28 | | 41.50 | Accepted |
| Hinge Hole ID (H3') | 41.28 | | 41.54 | Accepted |
| Hinge Hole ID (H4') | 41.28 | | 41.53 | Accepted |

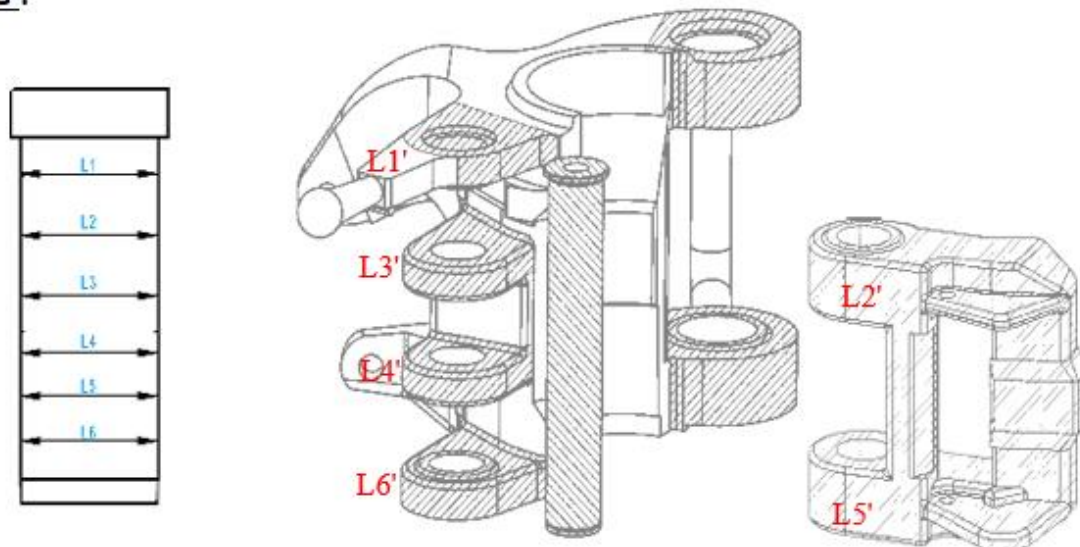
| Slip type elevator – CAT IV Dimensional Verification Checklist | | | | |

| Slip type elevator – CAT IV Dimensional Verification Checklist | | | | |
|---|---|---|---|---|
| Latch Pin OD (L1) | 34.87 | 0.76 | 34.72 | Accepted |
| Latch Pin OD (L2) | 34.87 | | 34.70 | Accepted |
| Latch Pin OD (L3) | 34.87 | | 34.71 | Accepted |
| Latch Pin OD (L4) | 34.87 | | 34.72 | Accepted |
| Latch Hole ID (L1') | 34.93 | | 34.93 | Accepted |
| Latch Hole ID (L2') | 34.93 | | 34.94 | Accepted |
| Latch Hole ID (L3') | 34.93 | | 34.94 | Accepted |
| Latch Hole ID (L4') | 34.93 | | 34.95 | Accepted |

\*\* Visual And MPI Was Carried out on the critical areas and load bearing components of the elevator and Found **Satisfactory for Further Use**.

\*\* CAT IV Inspection Was Carried Out on the Elevator and Found **Accepted**  
At The Time of Inspection

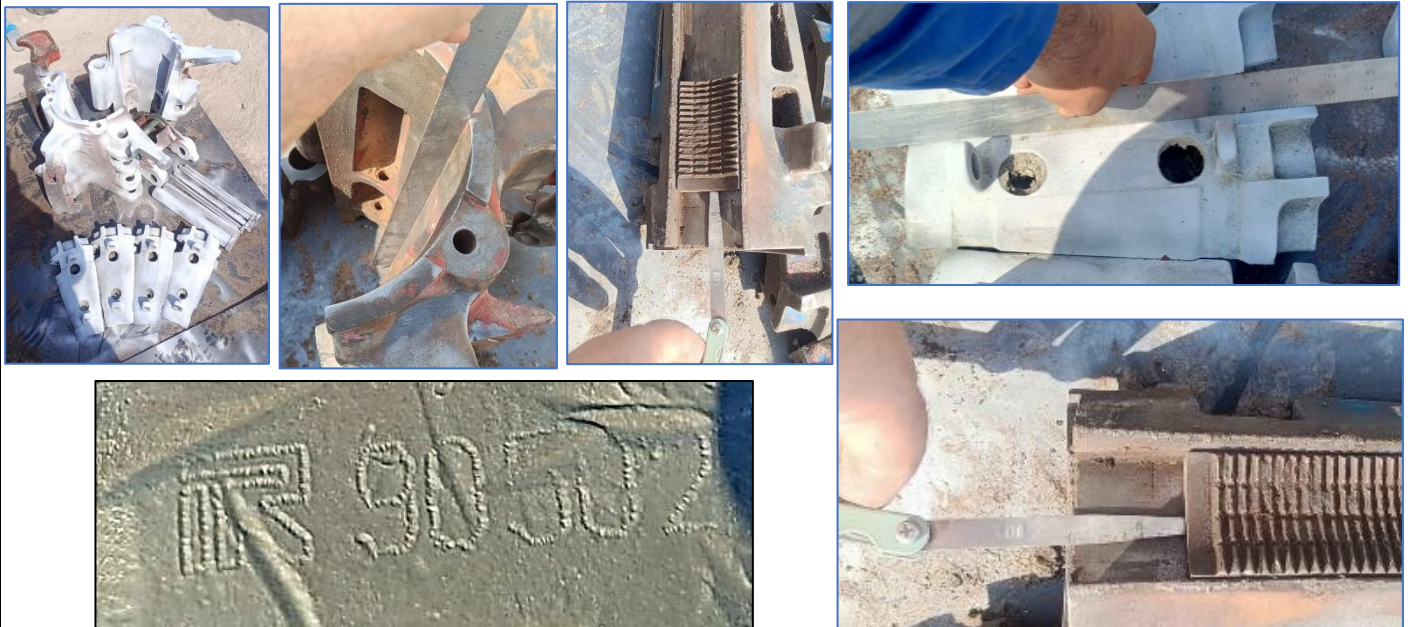
Visual and MPI carried out for the above description and found free of surface defects at the time of inspection

Identification of any part found to have a defect and a description of the defect: **None**

Particulars of any repair, renewal or alteration required to remedy the defect identified above: **None**

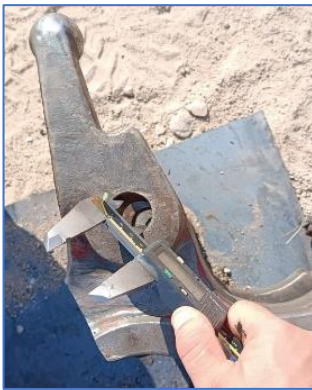
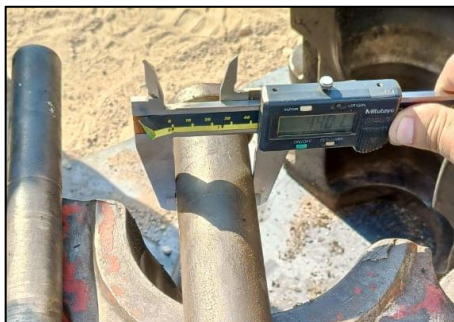
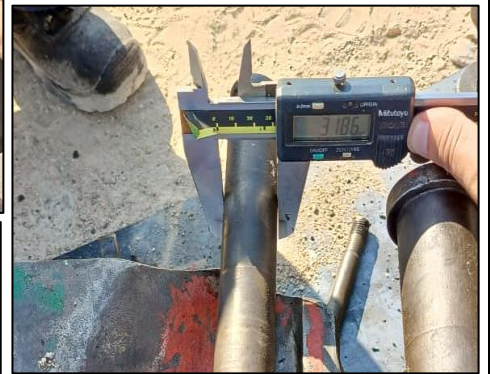
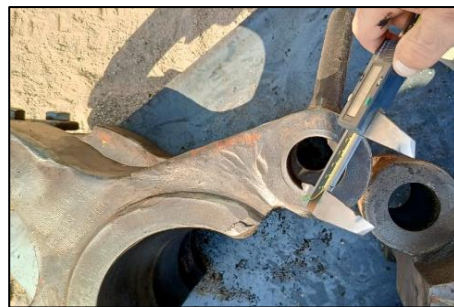
Visual and MPI carried out for the above description and found free of surface defects at the time of inspection

Identification of any part found to have a defect and a description of the defect: **None**

Particulars of any repair, renewal or alteration required to remedy the defect identified above: **None**
