# Aberdeen Technical Services and General Transportation

## Certificate of Visual Thorough Examination and Magnetic Particle Inspection (MPI)

Client:	<b>Hilong Oil Services &amp; Engineering</b>	Certificate Number:	ATS-11-24-4375- MPI-068
Rig Number:	HL99	Job No:	ATS-11-24-4375
Location:	Southern Rumila – RU264	Page No:	01 of 01
Date of Inspection:	13-11-2024	Next Inspection Date:	12-05-2025
Type of Inspection	Visual inspection & MPI (Wet Visible Method)	Ref. Standards:	ASTM E709, ASTM E 1444

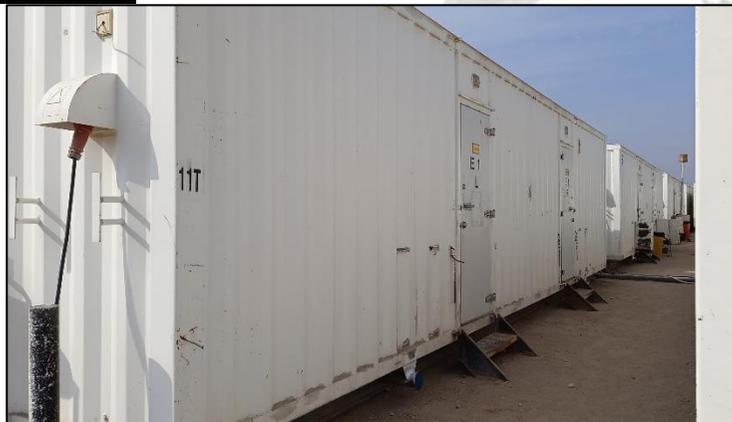
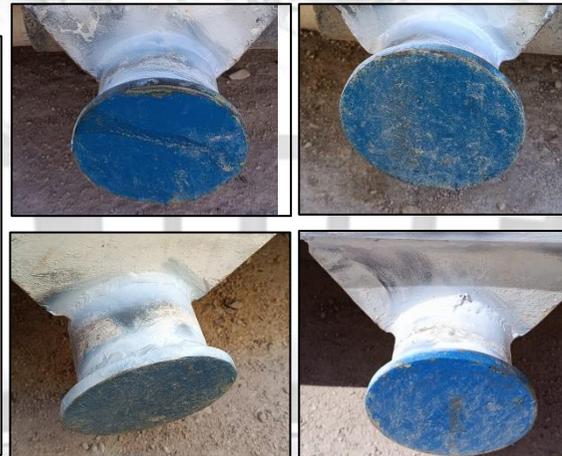
### PICTORIAL:

<b>Item Description: 4-man room caravan</b>		
SN	20182000267-1	20182000267-3
SN	20182000267-2	20182000267-4
SWL	50 KN / each	
Dimensions	L x W x H : 12900 x 3120 x 3000 mm	
Weights:	weight: 11 T	Payload: NA
<b>Unit Serial Number: 20182000267</b>		
<b>Details of inspection method(s):</b> Visible magnetic particle inspection		
<b>Inspection Results:</b> MPI WAS CARRIED OUT ON THE CRITICAL AND WELDING AREAS OF LIFTING POINTS (MIDDLE LUGS) OF THE ABOVE-MENTIONED ITEM AND FOUND NO CRACKS OR RELEVANT INDICATIONS AT THE TIME OF INSPECTION.		
<b>Remarks: ACCEPTED</b>
