Aberdeen Technical Services and General Transportation

Certificate of Visual Thorough Examination and Magnetic Particle Inspection (MPI)

Client:	Hilong Oil Services & Engineering	Certificate Number:	ATS-11-24-4375- MPI-073
Rig Number:	HL99	Job No:	ATS-11-24-4375
Location:	Southern Rumila – RU264	Page No:	01 of 01
Date of Inspection:	13-11-2024	Next Inspection Date:	12-05-2025
Type of Inspection	Visual inspection & MPI (Wet Visible Method)	Ref. Standards:	ASTM E709, ASTM E 1444

Item Description: 4-man room caravan		
SN	20182000262-1	20182000262-3
SN	20182000262-2	20182000262-4
SWL	50 KN / each	
Dimensions	L x W x H : 12900 x 3120 x 3000 mm	
Weights:	weight: 11 T	Payload: NA

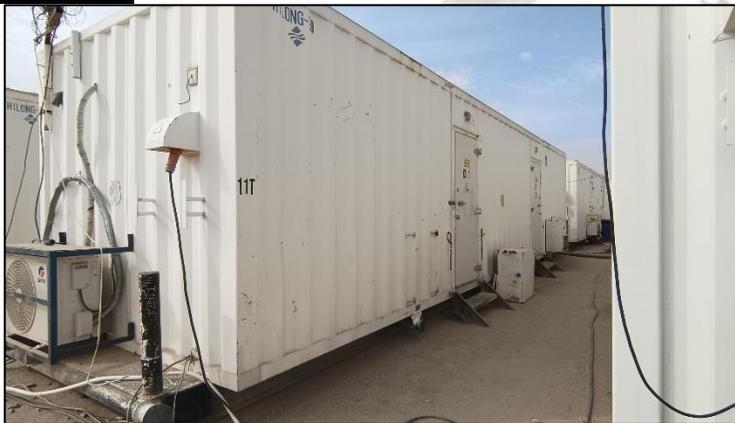
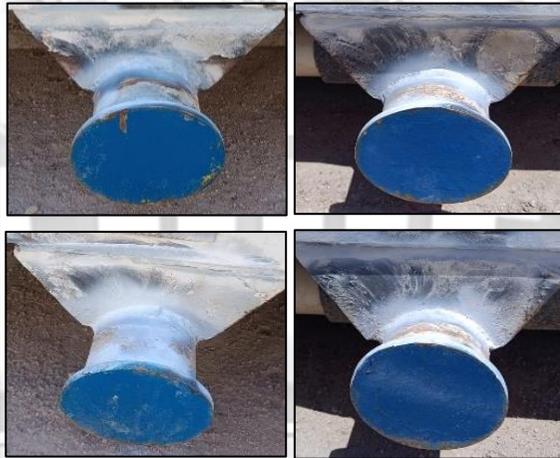
PICTORIAL:

Inspection Results:
MPI WAS CARRIED OUT ON THE CRITICAL AND WELDING AREAS OF LIFTING POINTS (MIDDLE LUGS) OF THE ABOVE-MENTIONED ITEM AND FOUND NO CRACKS OR RELEVANT INDICATIONS AT THE TIME OF INSPECTION.

Remarks: ACCEPTED
