## Certificate of Visual Thorough Examination and Magnetic Particle Inspection (MPI)

| Client: | Hilong Oil Services & Engineering | Certificate Number: | ATS-11-24-4375- MPI-076 |

### Item Description: western dining caravan

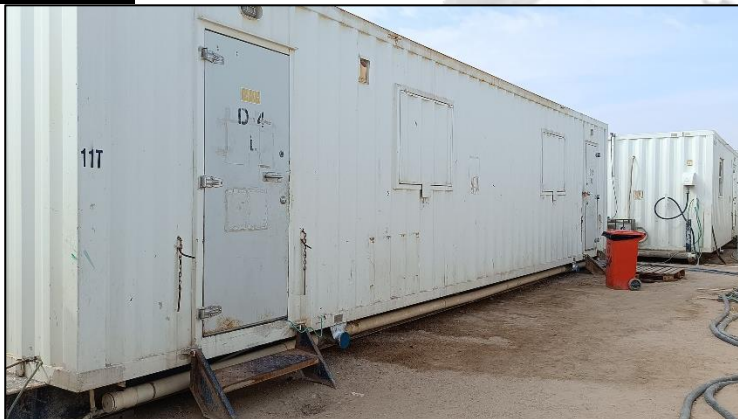
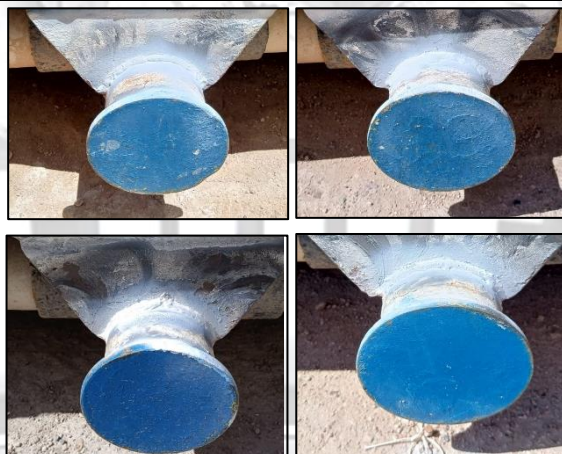
### PICTORIAL:

MPI WAS CARRIED OUT ON THE CRITICAL AND WELDING AREAS OF LIFTING POINTS (MIDDLE LUGS) OF THE ABOVE-MENTIONED ITEM AND FOUND NO CRACKS OR RELEVANT INDICATIONS AT THE TIME OF INSPECTION.

Remarks: **ACCEPTED**
