# Aberdeen Technical Services and General Transportation

## Certificate of Visual Thorough Examination and Magnetic Particle Inspection (MPI)

Client:	<b>Hilong Oil Services &amp; Engineering</b>	Certificate Number:	ATS-11-24-4375- MPI-086
Rig Number:	HL99	Job No:	ATS-11-24-4375
Location:	Southern Rumila – RU264	Page No:	01 of 01
Date of Inspection:	13-11-2024	Next Inspection Date:	12-05-2025
Type of Inspection	Visual inspection & MPI (Wet Visible Method)	Ref. Standards:	ASTM E709, ASTM E 1444

<b>Item Description: 1-man room caravan</b>		
SN	20182000256-1	20182000256-2
SN	20182000256-3	20182000256-4
SWL	50 KN / each	
Dimensions	L x W x H : 12900 x 3120 x 3000 mm	
Weights:	weight: 11 T	Payload: NA

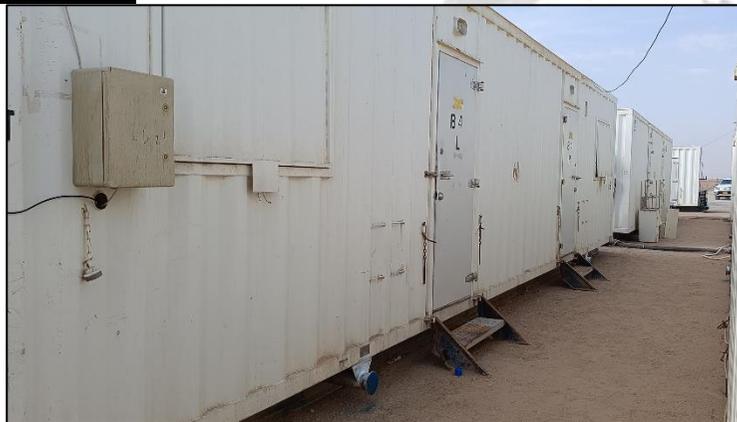
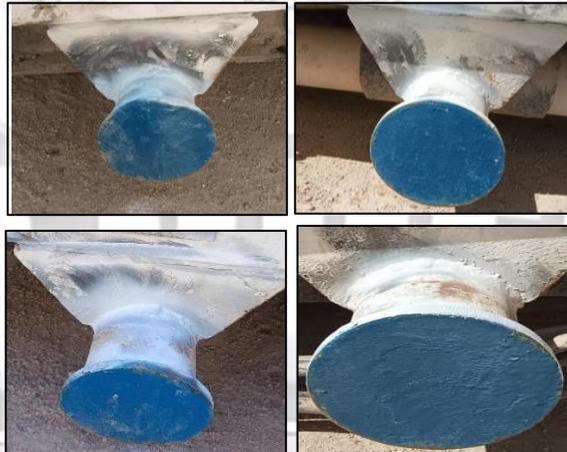
**PICTORIAL:**

**Inspection Results:**  
MPI WAS CARRIED OUT ON THE CRITICAL AND WELDING AREAS OF LIFTING POINTS (MIDDLE LUGS) OF THE ABOVE-MENTIONED ITEM AND FOUND NO CRACKS OR RELEVANT INDICATIONS AT THE TIME OF INSPECTION.

**Remarks: ACCEPTED**
